Re : Right to Repair Enquiry

By way of my submission, I would like to describe for you my recent experience with Canon Australia in relation to my three Canon printers.

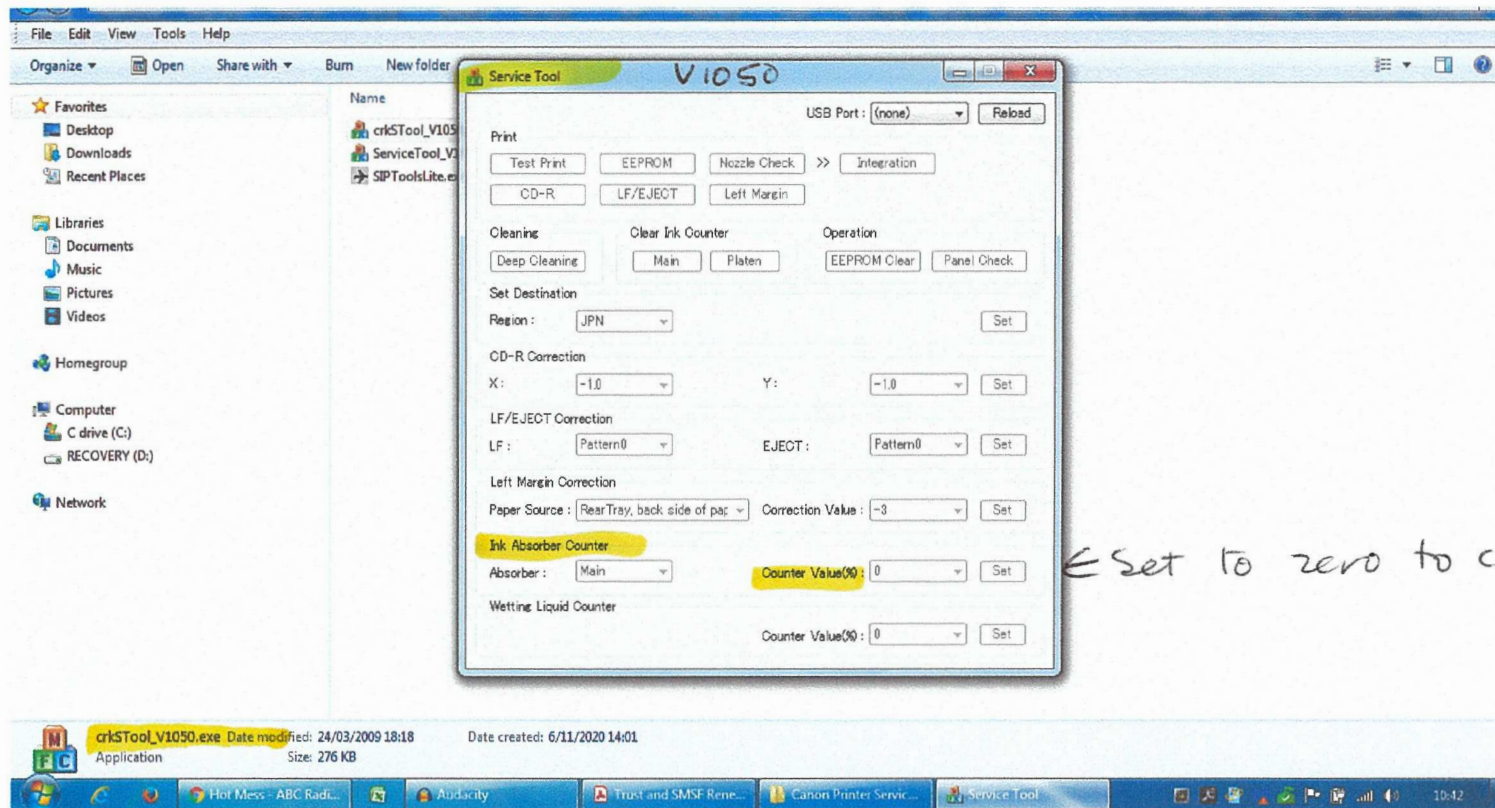
Service Tool

The ink absorber page counter needs to be reset using a service tool. Service tool is a software for resetting Canon printer and its counter. This is a tool used by our technicians in repairing printer issues and to access the internal memory of the machine.

The ink absorber page counter needs to be reset using a service software for resetting Canon printer and its counter. This is a technicians in repairing printer issues and to access the internal machine.

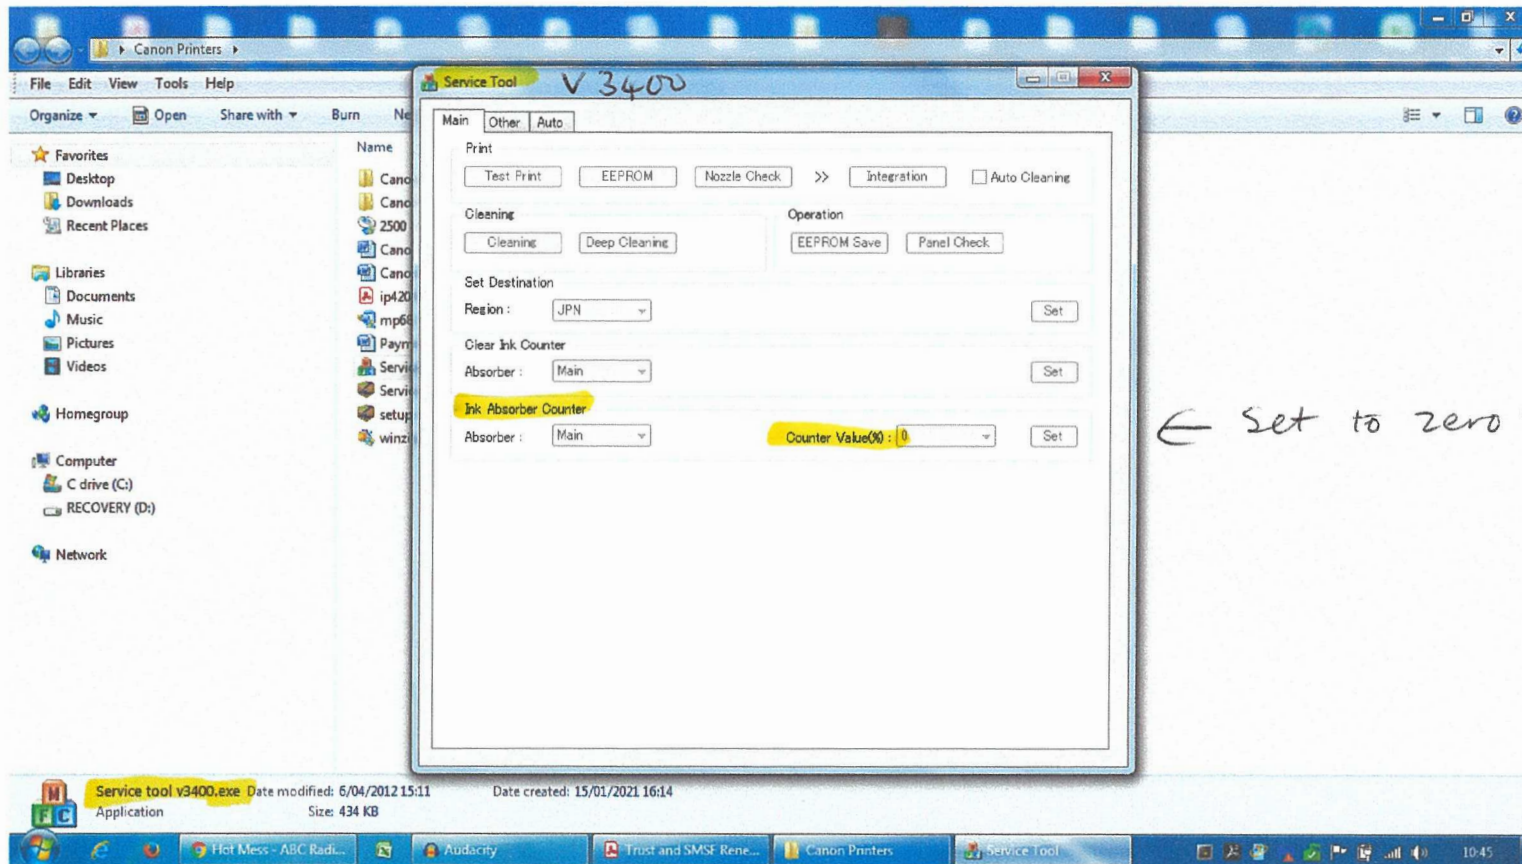
Service Tool

← Set to zero to clear error
